THE CALIFORNIA EARTHQUAKE OF APRIL 18, 1906

STATE EARTHQUAKE INVESTIGATION COMMISSION

IN TWO VOLUMES AND ATLAS

ANDREW C. LAWSON, CHAIRMAN

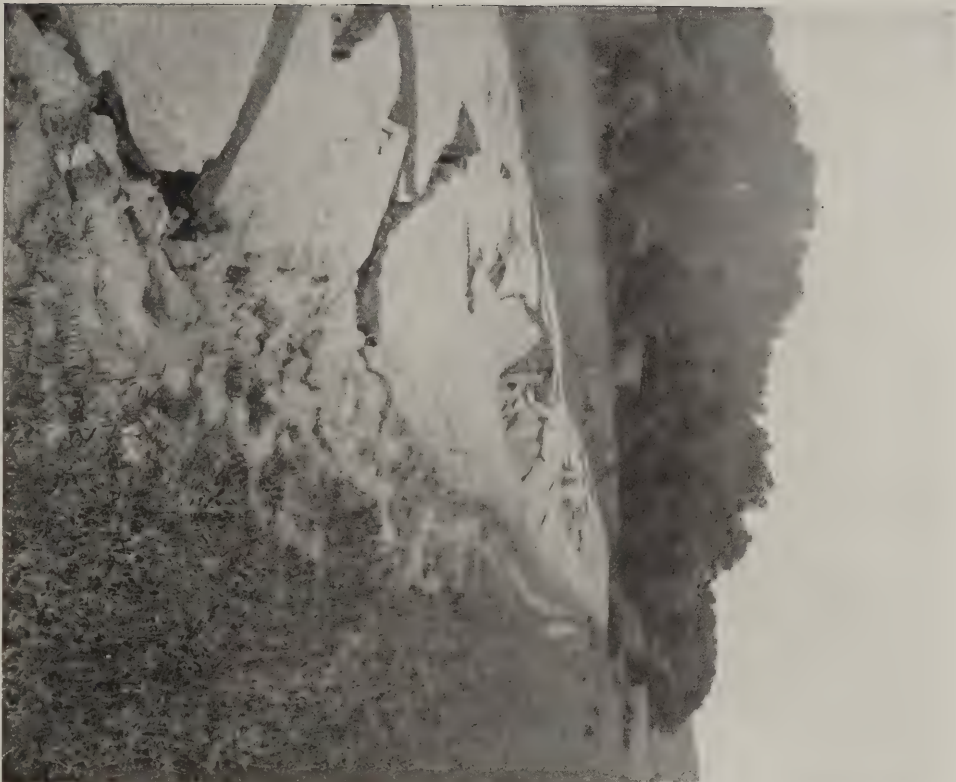
A. Road embankment broken by shaking of soft ground beneath. Southwest of Point Reyes Station and 10 rods from fault-trace. G. K. G.

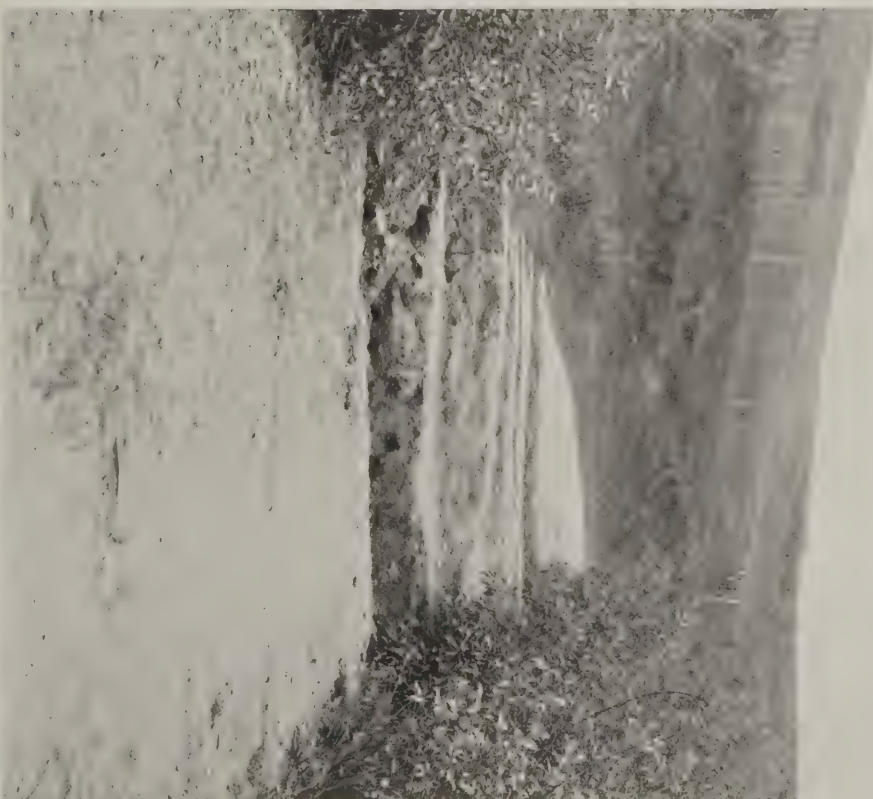
B. Faults in road embankment, southwest of Point Reyes Station. Fault-trace is beyond fence. Ground lurched toward marsh of Bear Valley Creek. G. K. G.

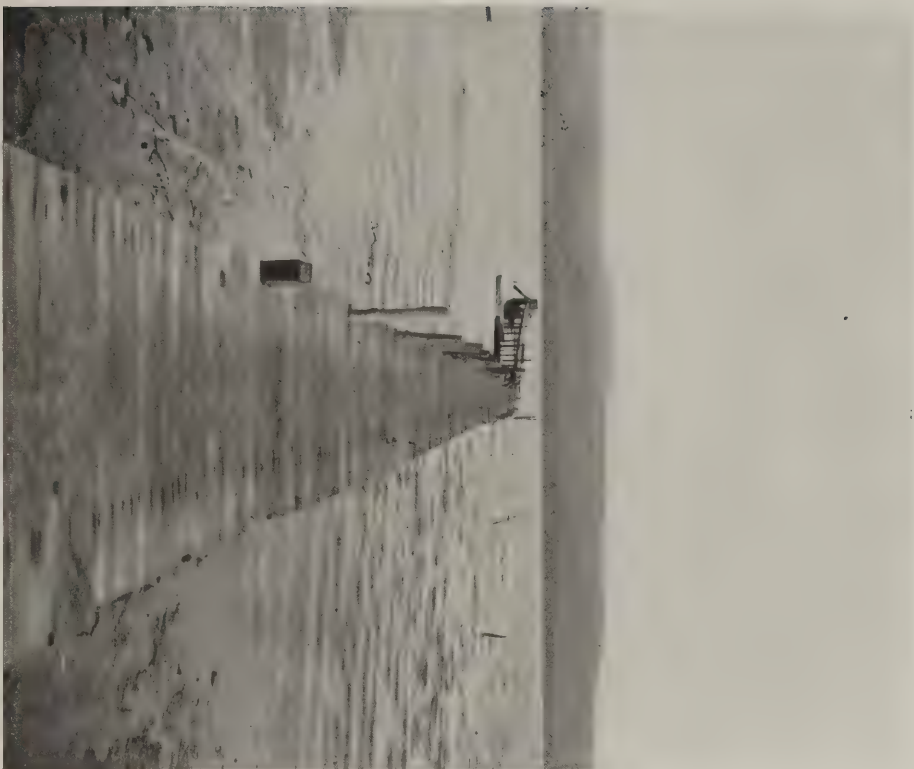
A. Martinielli's pier at Inverness. Originally straight; shifted and broken by earthquake. Repaired before photograph was taken. G. K. G.

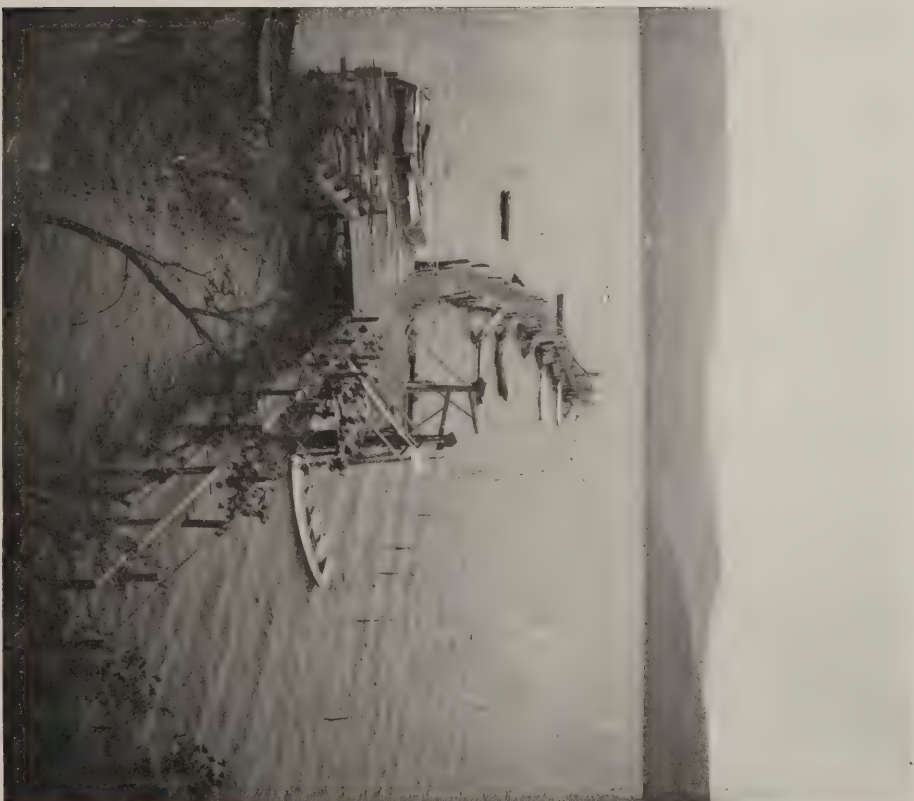
B. Bailey's pier at Inverness. Originally straight; shifted and much broken by earthquake. In subsequent repairs curvature caused by earthquake was retained. G. K. G.

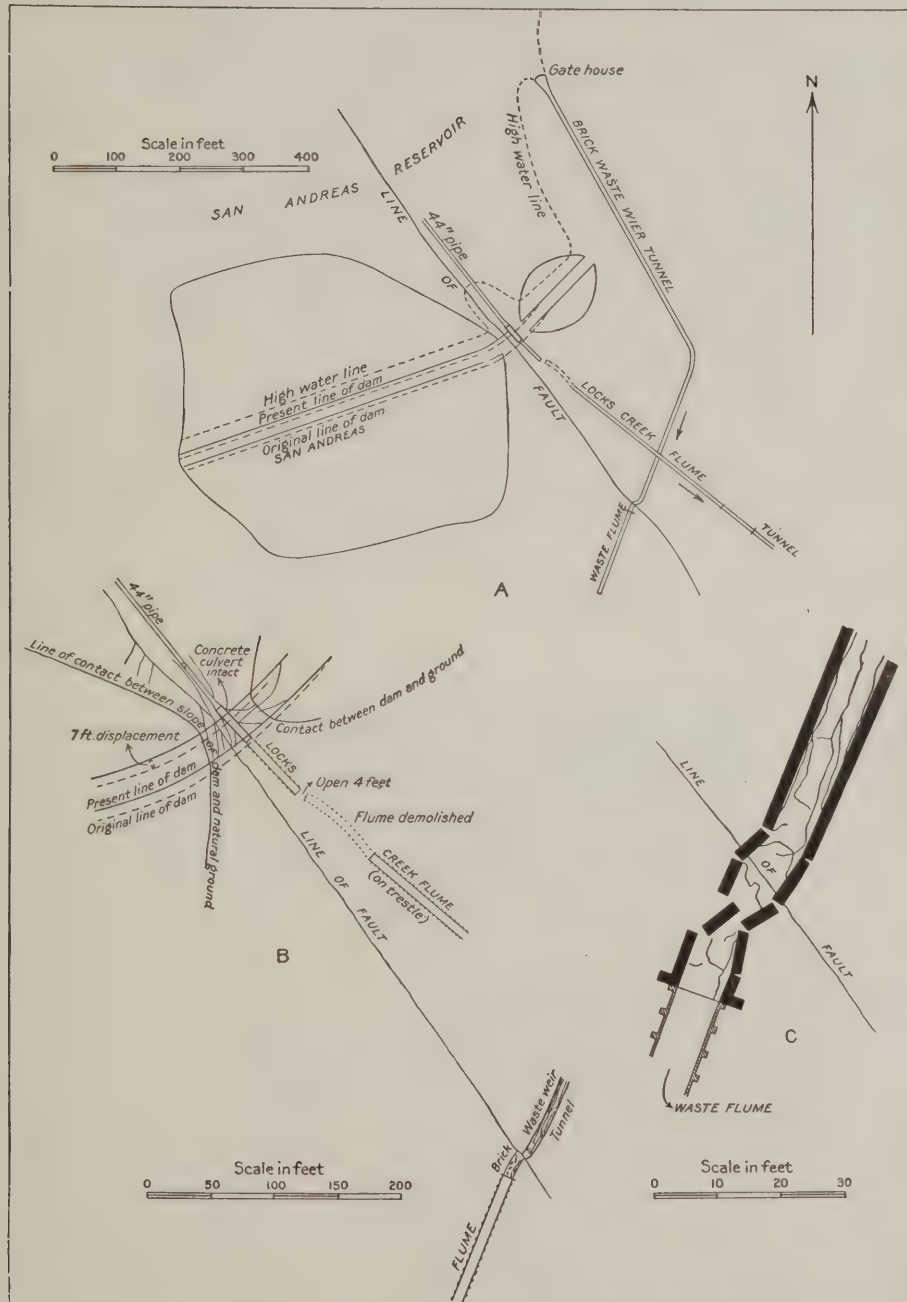
FIG. 36.— Intersection of San Andreas dam by fault. A. Plan of dam in two parts, with rock between. B. Relation of dam to waste weir tunnel. C. Detail of waste weir tunnel.

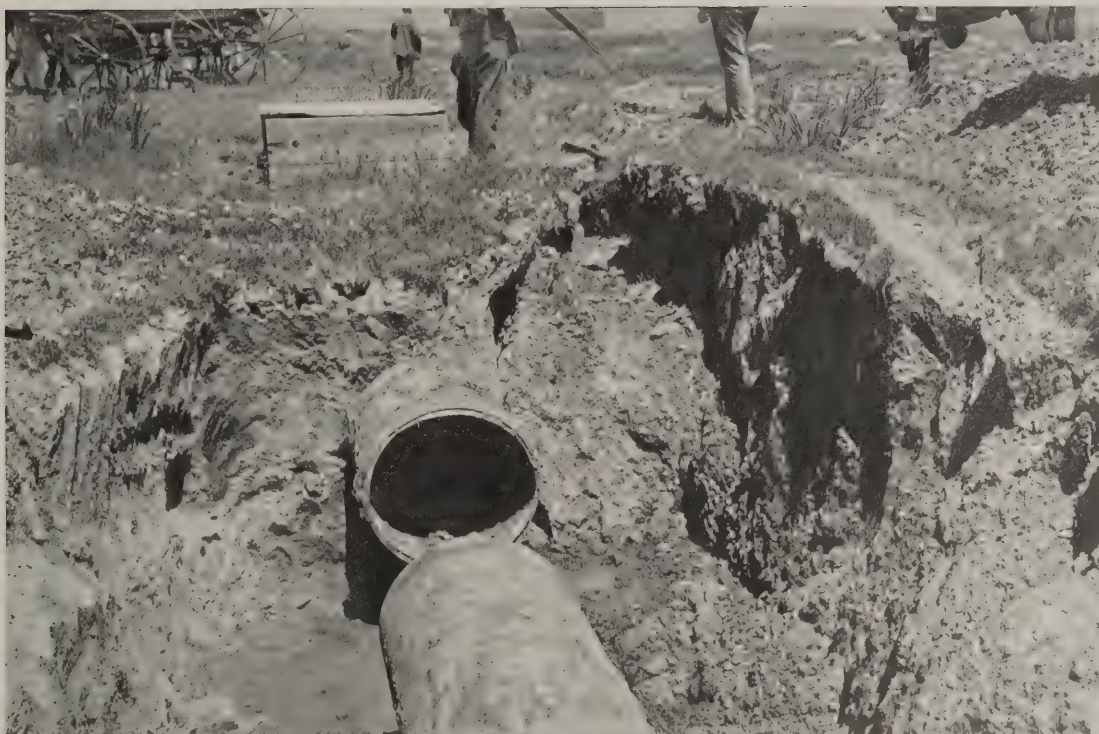
A. Rupture of 30-inch water-pipe by fault. Northwest of San Andreas Lake. A. C. L.

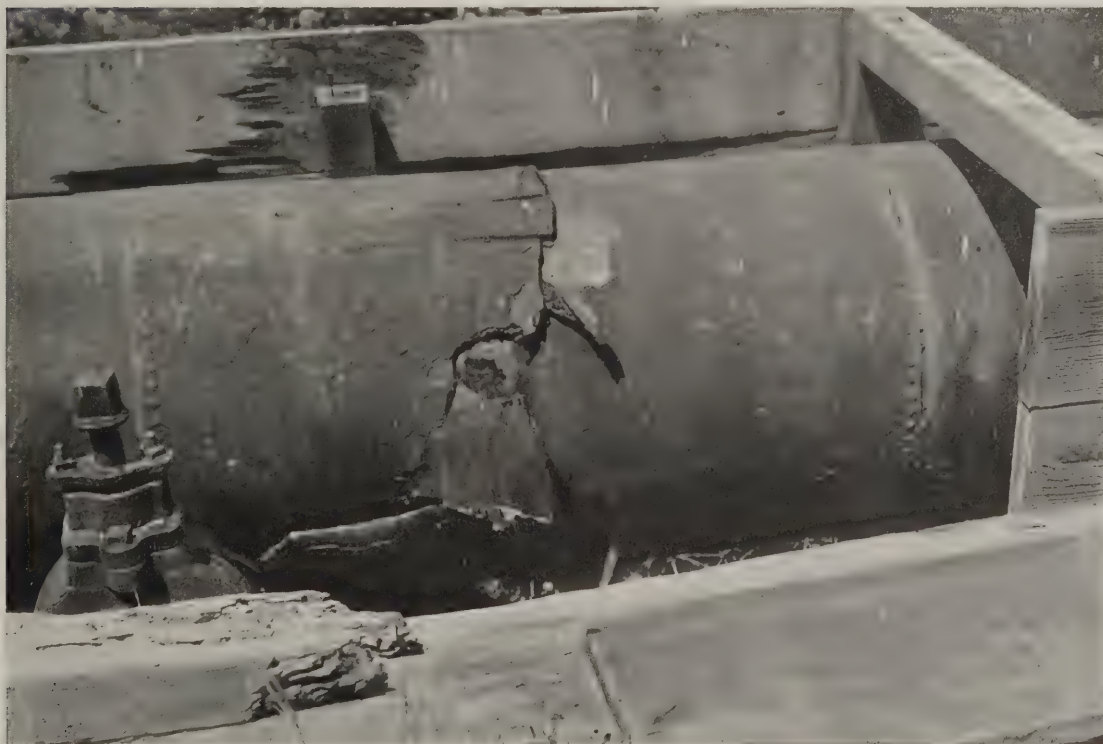
B. Thrust of 30-inch water-pipe by fault, northwest of San Andreas Lake. Amount of telescoping is 58 inches. A. C. L.

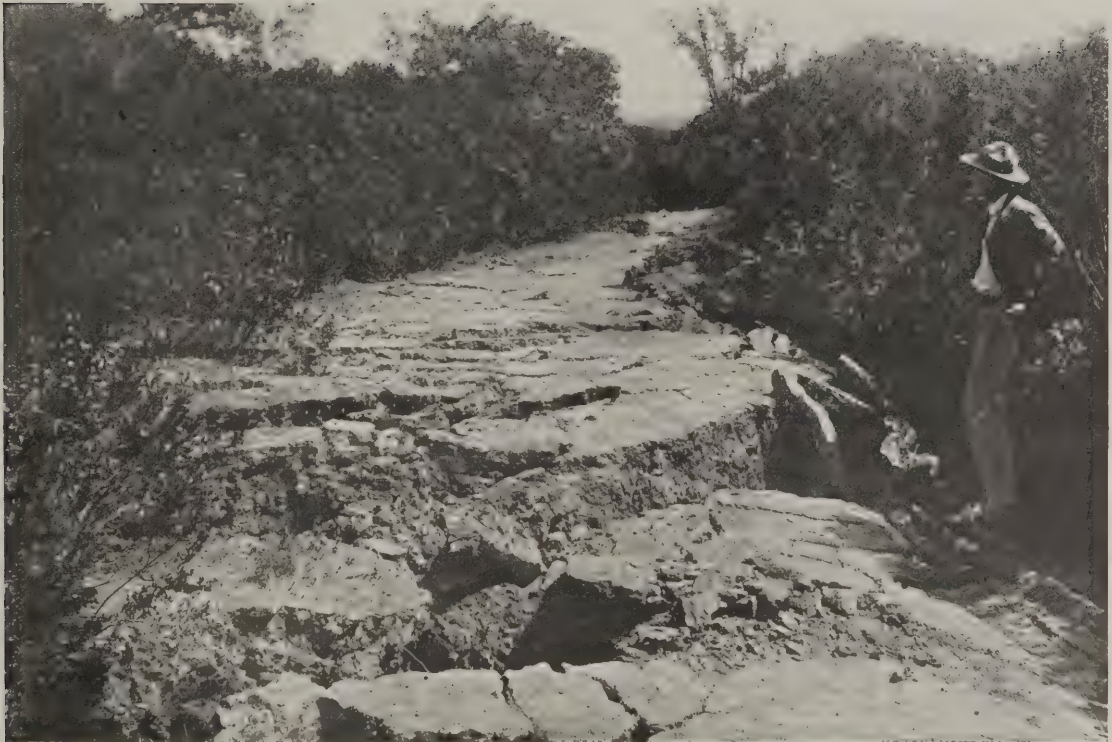
A. Offset of Alpine road 5 miles west of Stanford University. Per J. C. B.

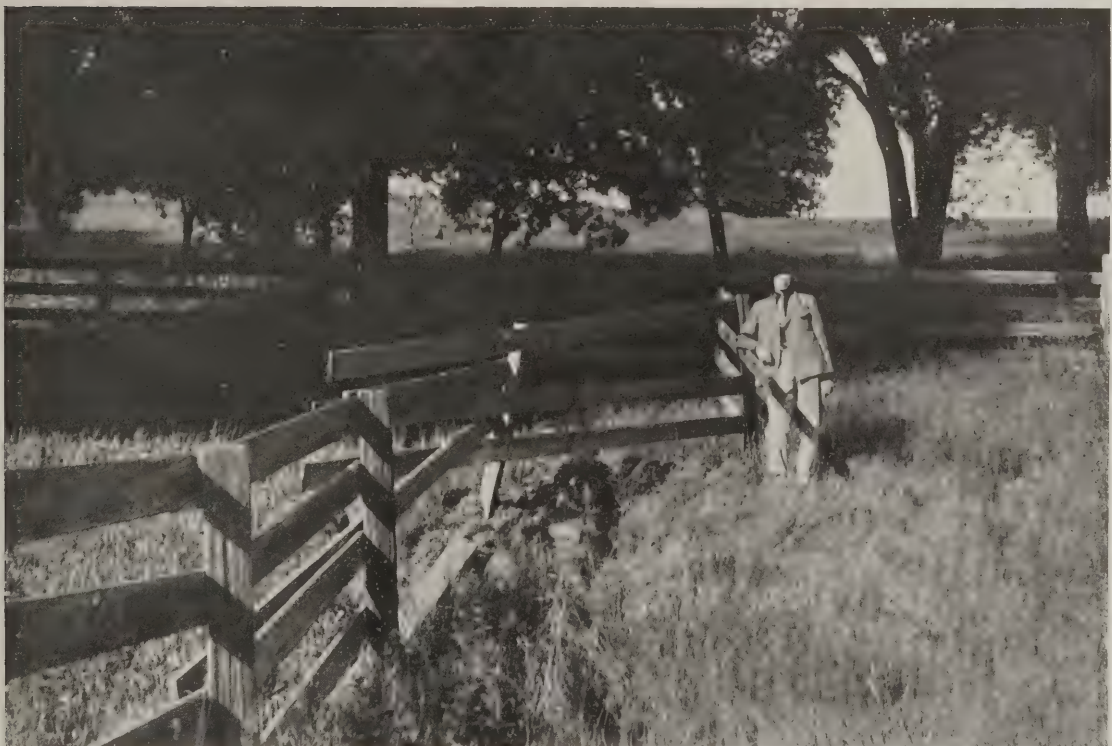
B. Offset of 8 feet in fence on Folger ranch, near Woodville. Per J. C. B.

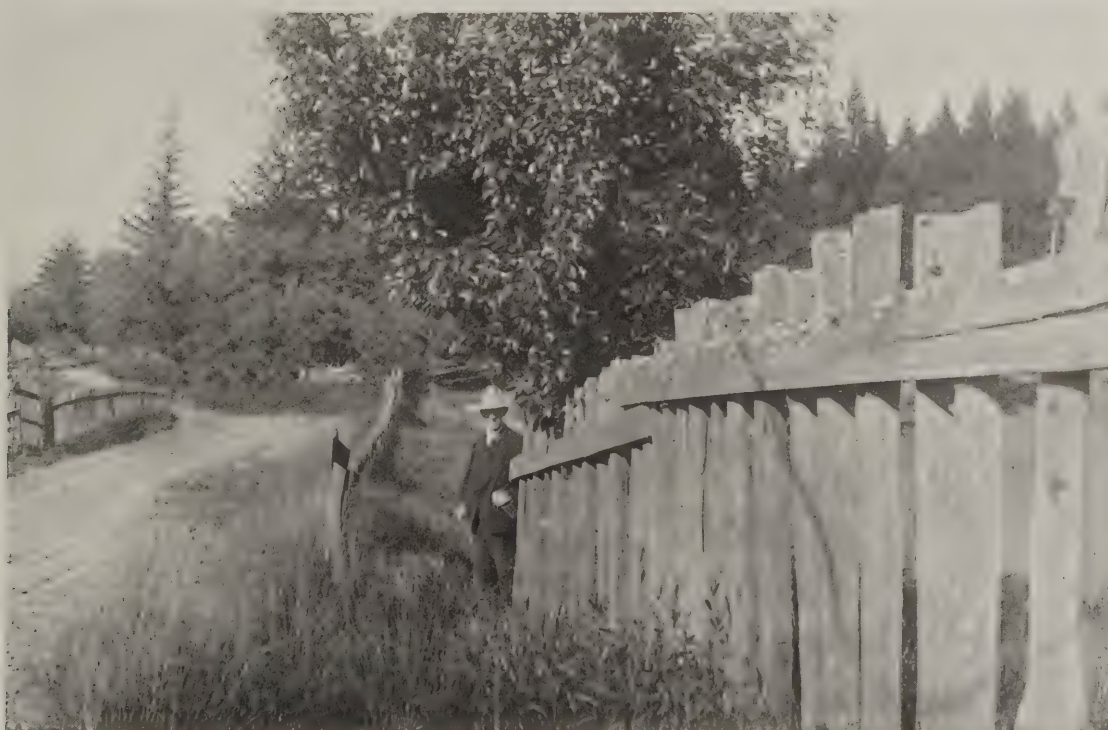
B. Offset in fence at Morrell's ranch, above tunnel at Wright station. This particular displacement was not found in tunnel. G. A. W.

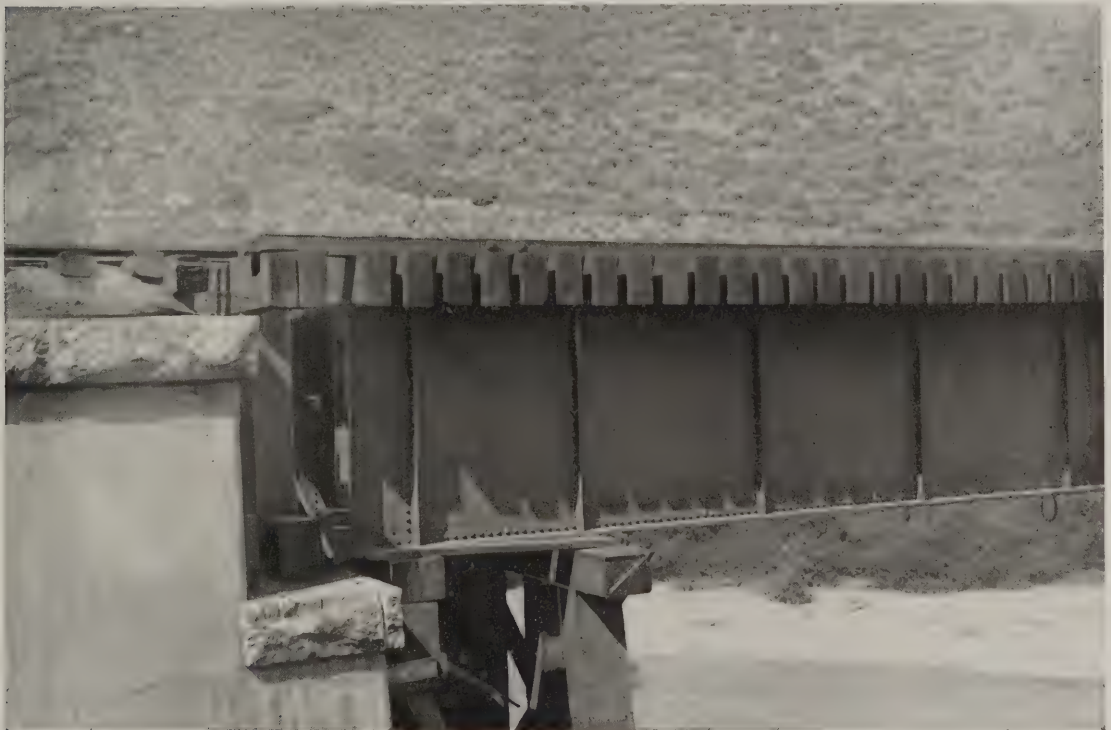
B. Steel bridge over Pajaro River, near Chittenden, dragged from its abutment 3.5 feet. Compare Fig. 43. A. C. L.

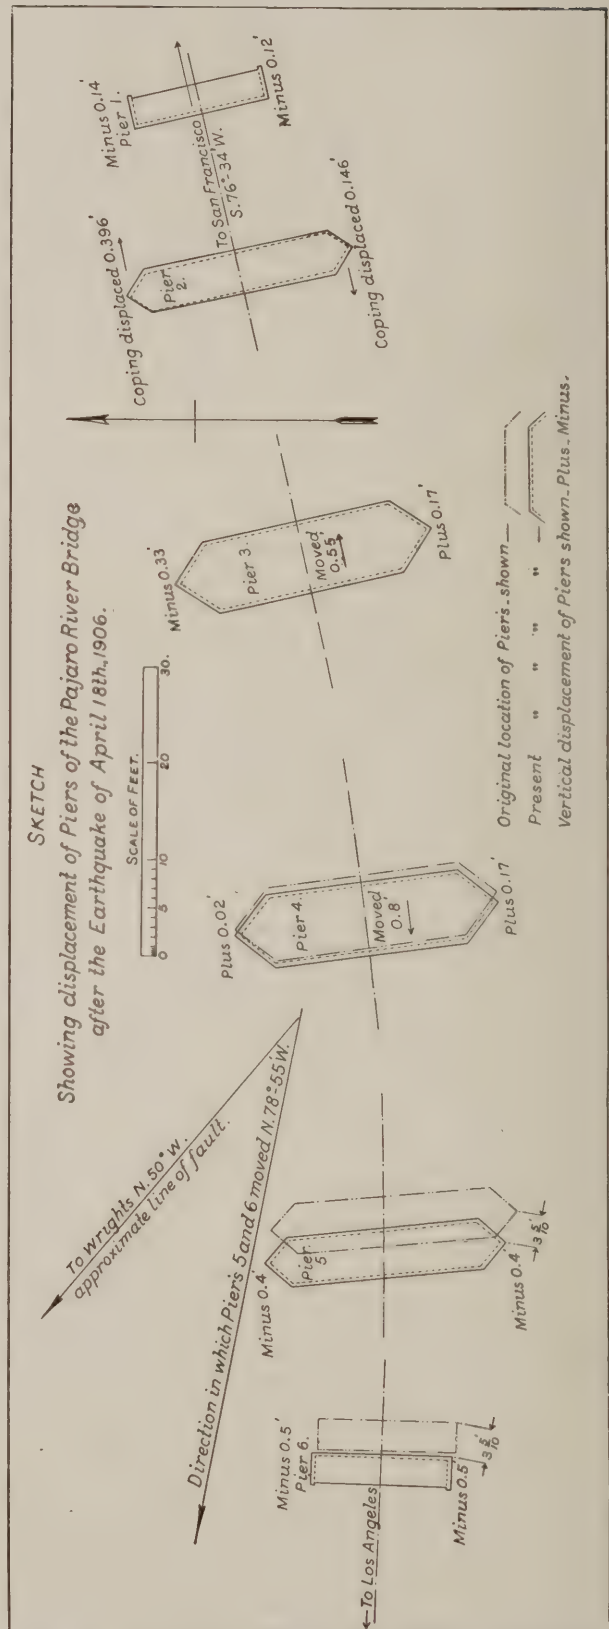
FIG. 43.—Displacement of piers of steel bridge at Chittenden.

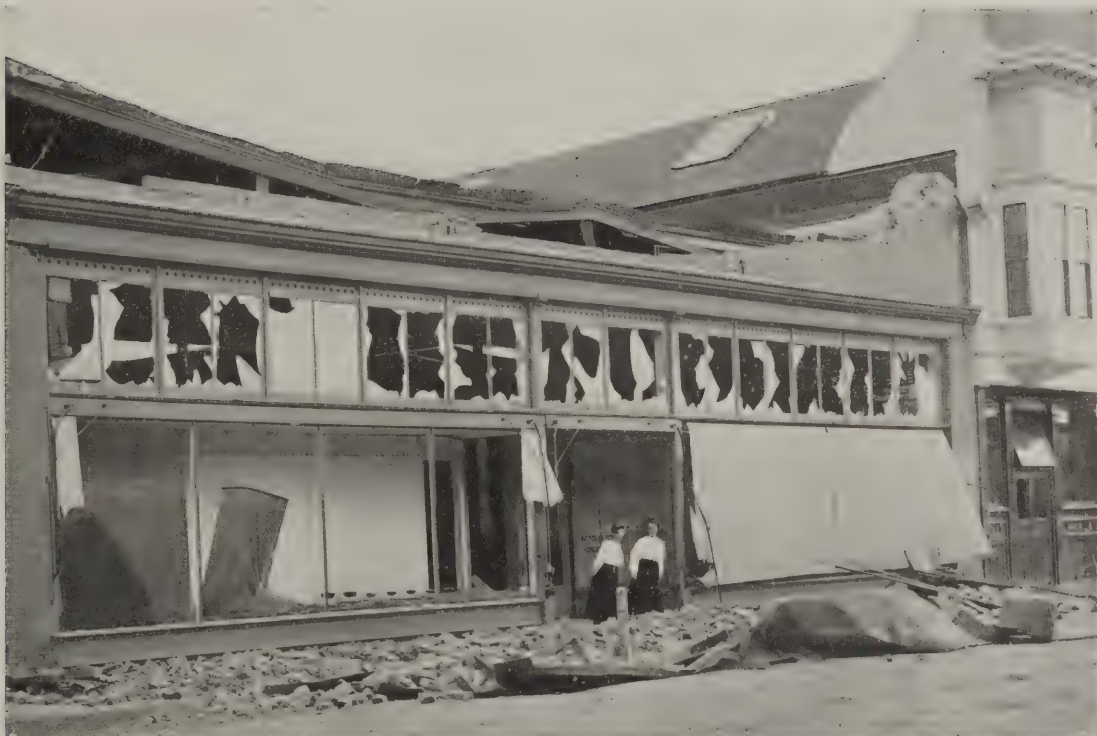
A. Wrecked stores. Ferndale, Humboldt County.

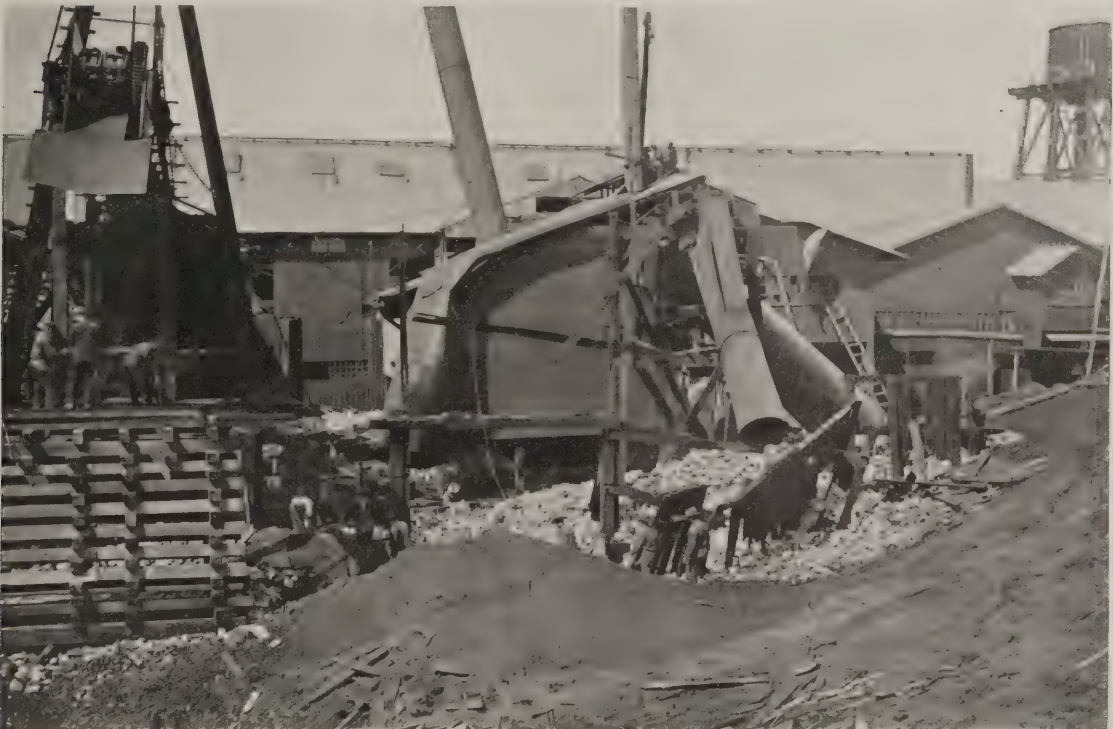
B. U. C. Co.'s mill, Fort Bragg. Smoke stack 5 feet in diameter. Entire structure thrown out of plumb to south, 1 foot in 20 feet.

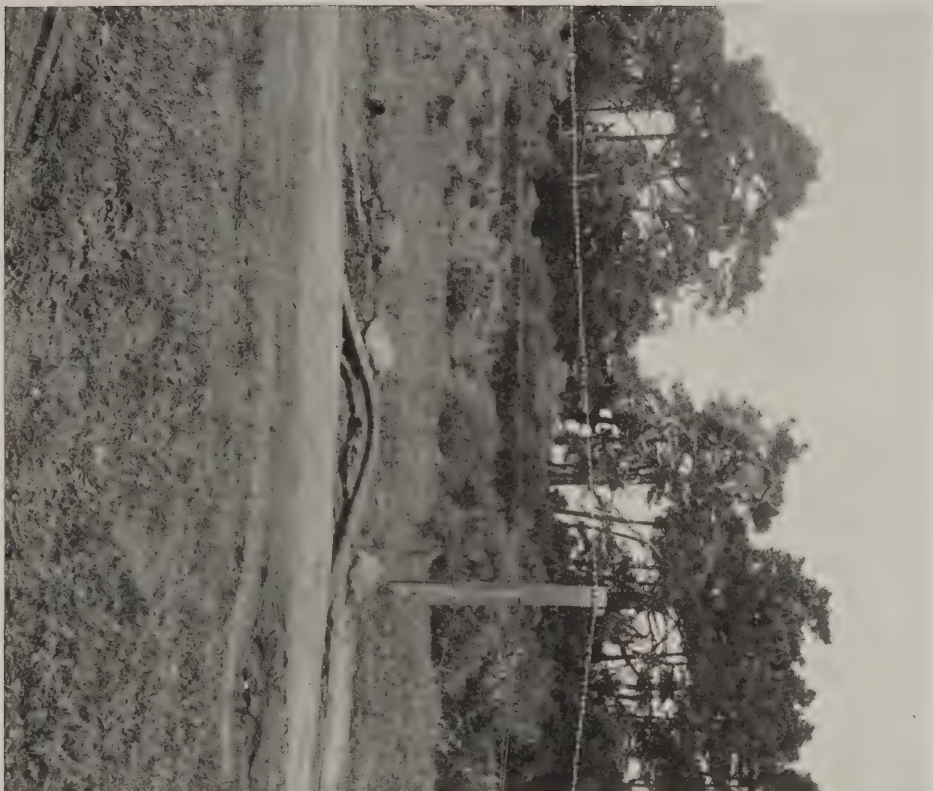
A. Buckled water-pipe, Inverness. G. K. G.

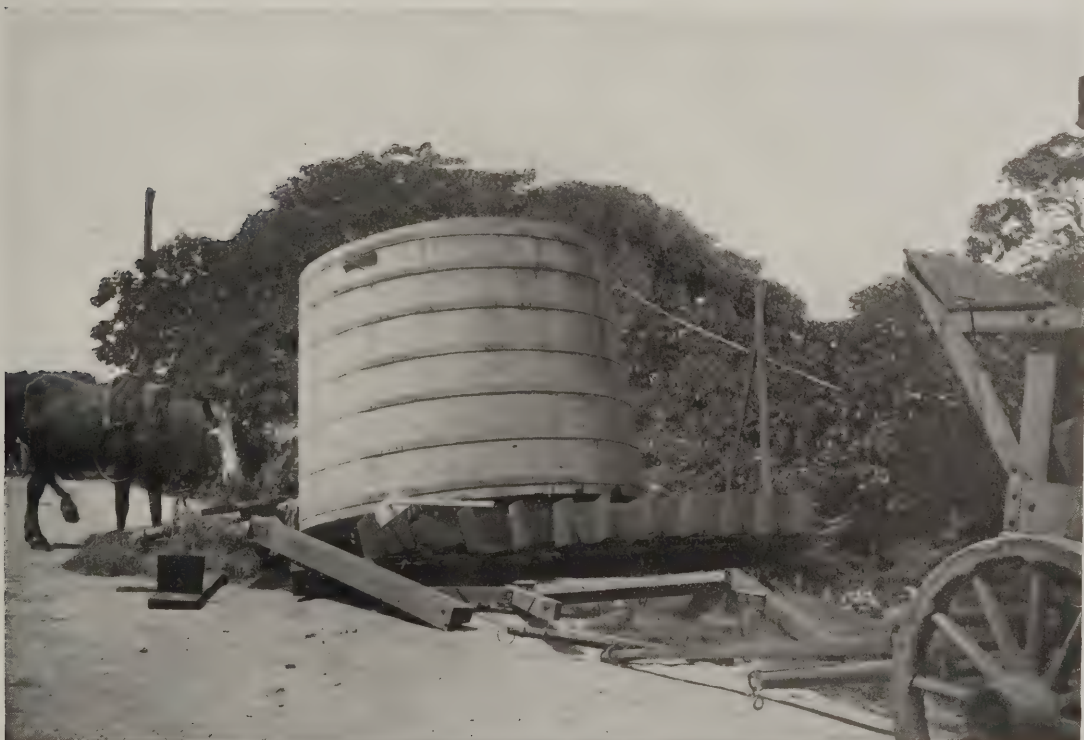
B. Wrecked water-tank near Inverness. G. K. G.

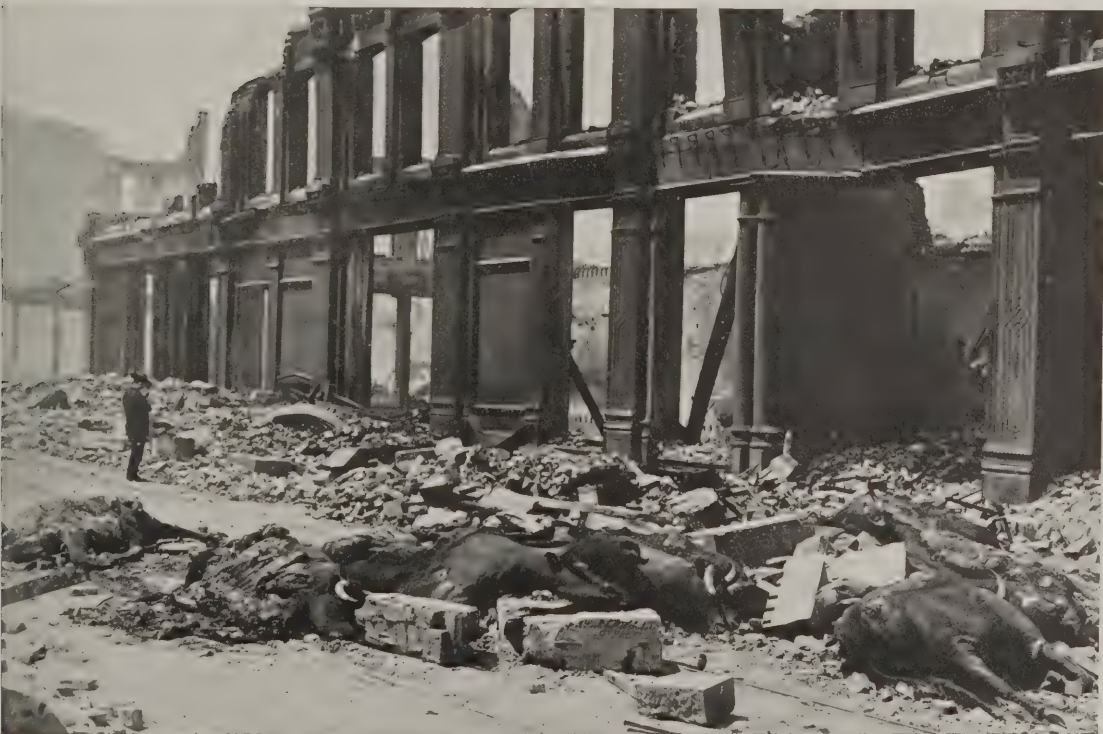
B. Cattle killed by falling masonry at time of earthquake, San Francisco.

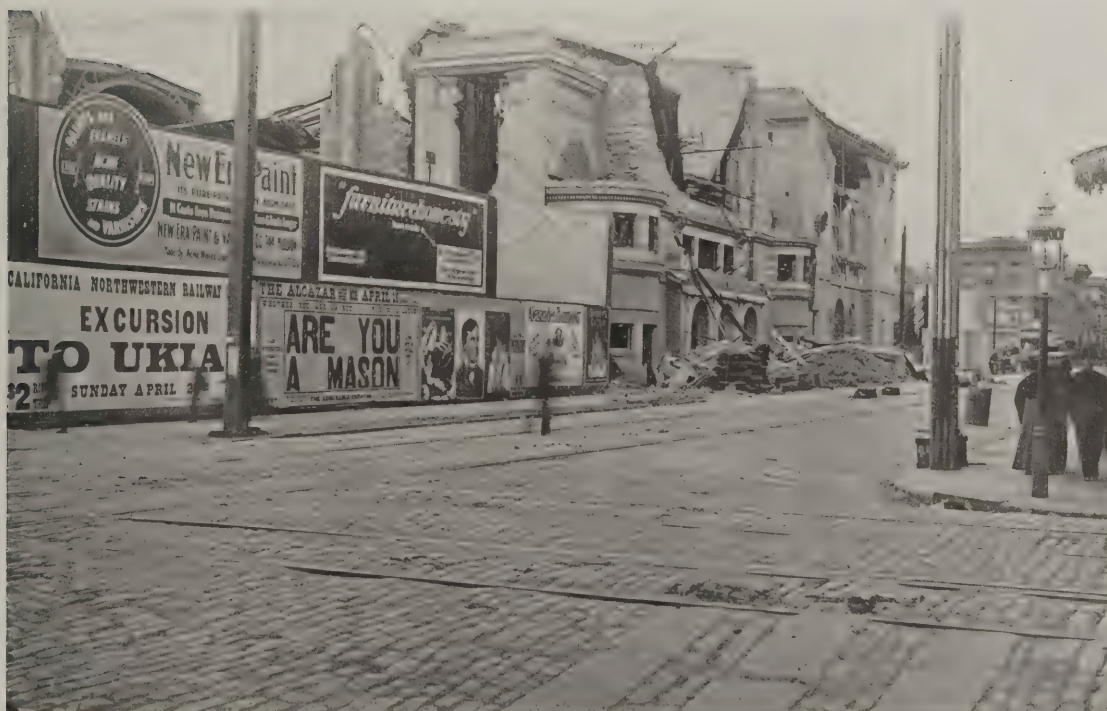
B. Geary Street, between Filmore and Steiner Streets, San Francisco. Buildings of mediocre construction on sand and alluvium of no great depth. A. C. L.

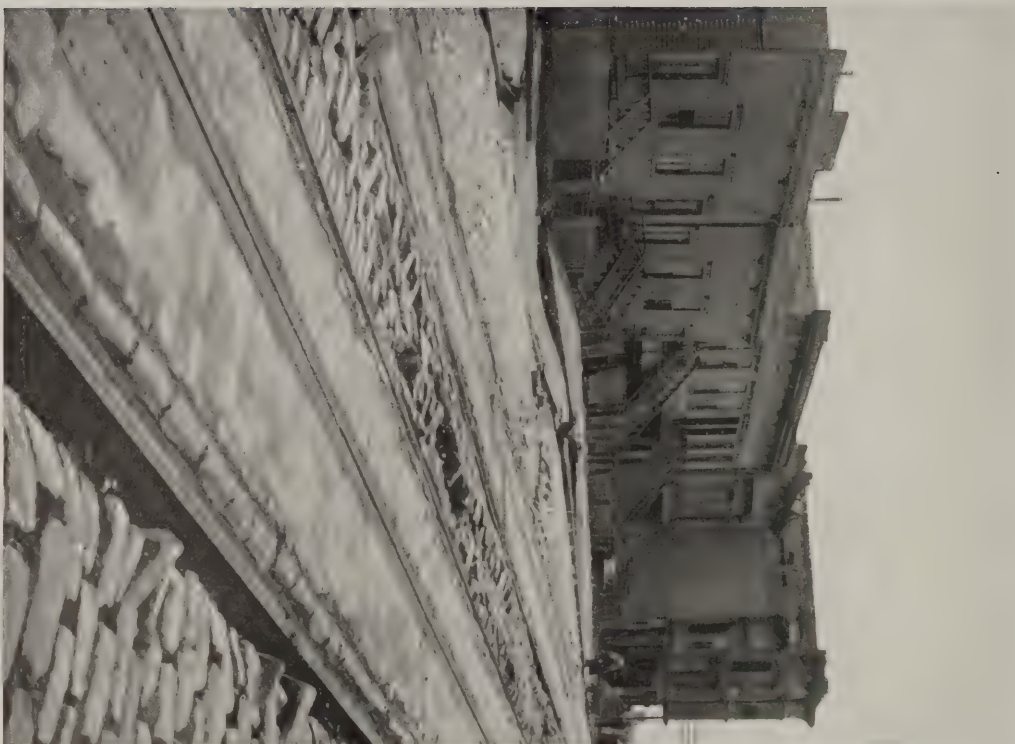
A. Ninth Street, between Bryant and Brannan. Undulation and fissuring of pavement and sidewalks. Houses over-trough have been dropt from their underpinning. G. K. G.

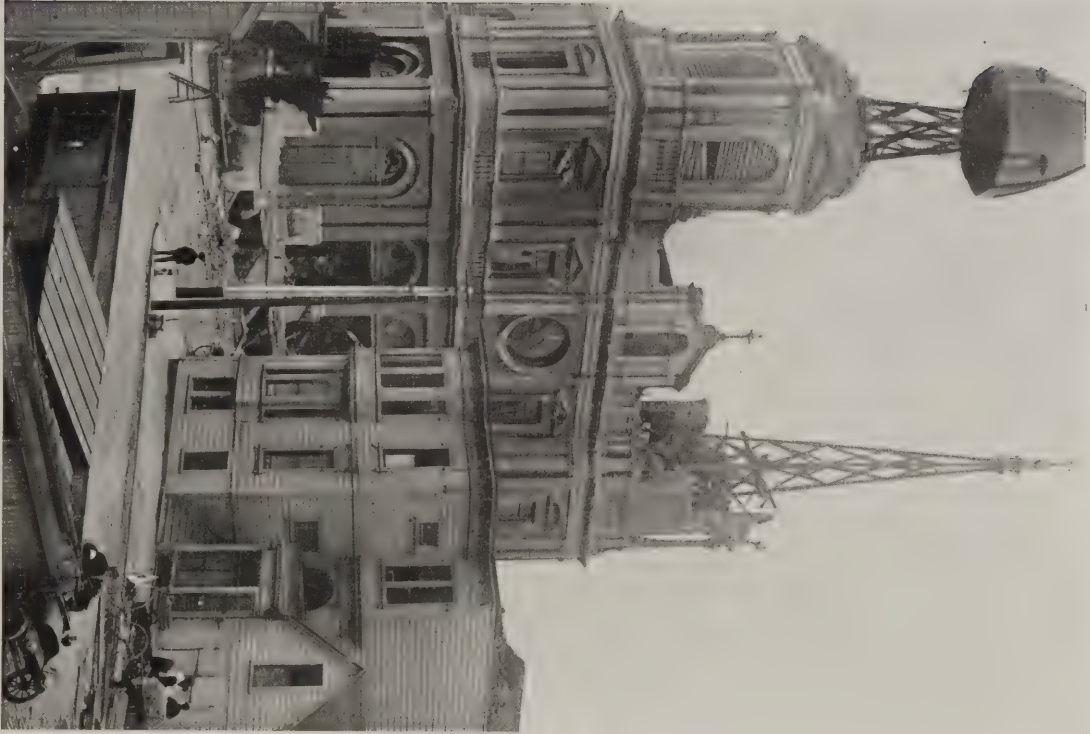
A. St. Dominic's Church, Bush and Steiner Streets, Brick and masonry structure upon sand and alluvium of no great depth. A. C. L.

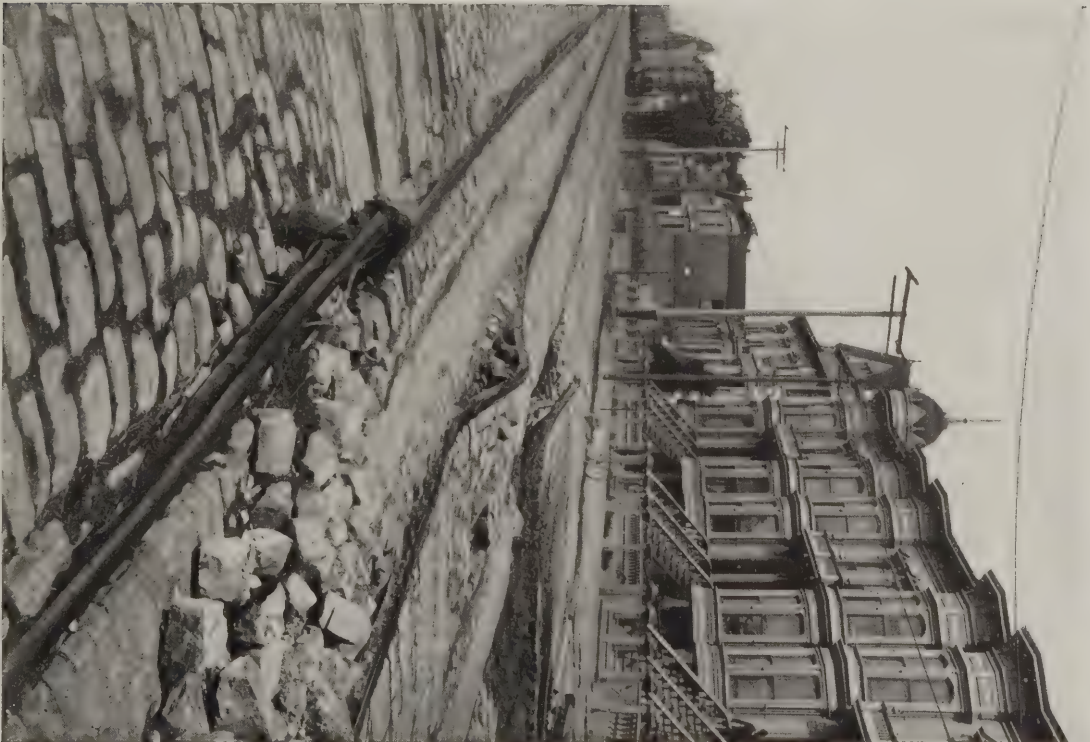
B. Looking south on Howard Street from near Seventeenth Street. Compression flexure of car rails. G. K. G.

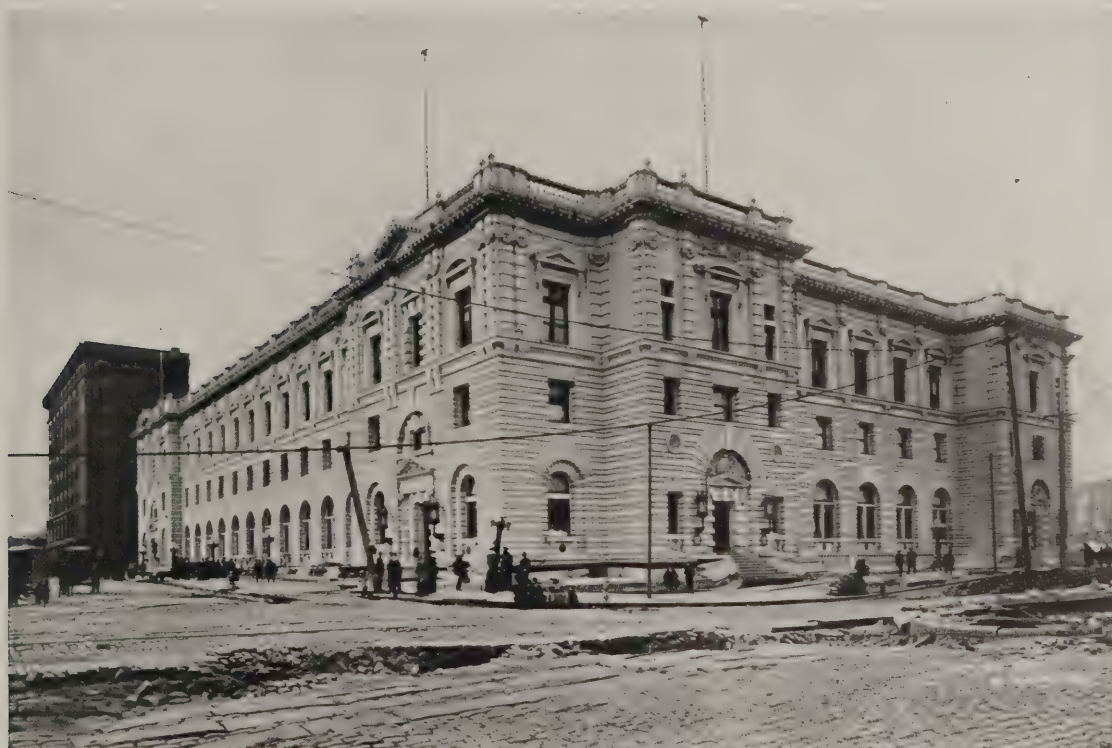
B. San Francisco Post-office, Mission and Seventh Streets. Near corner of building is on edge of old marsh. Ground over marsh sank and lurched. W. E. Worden, Photo.

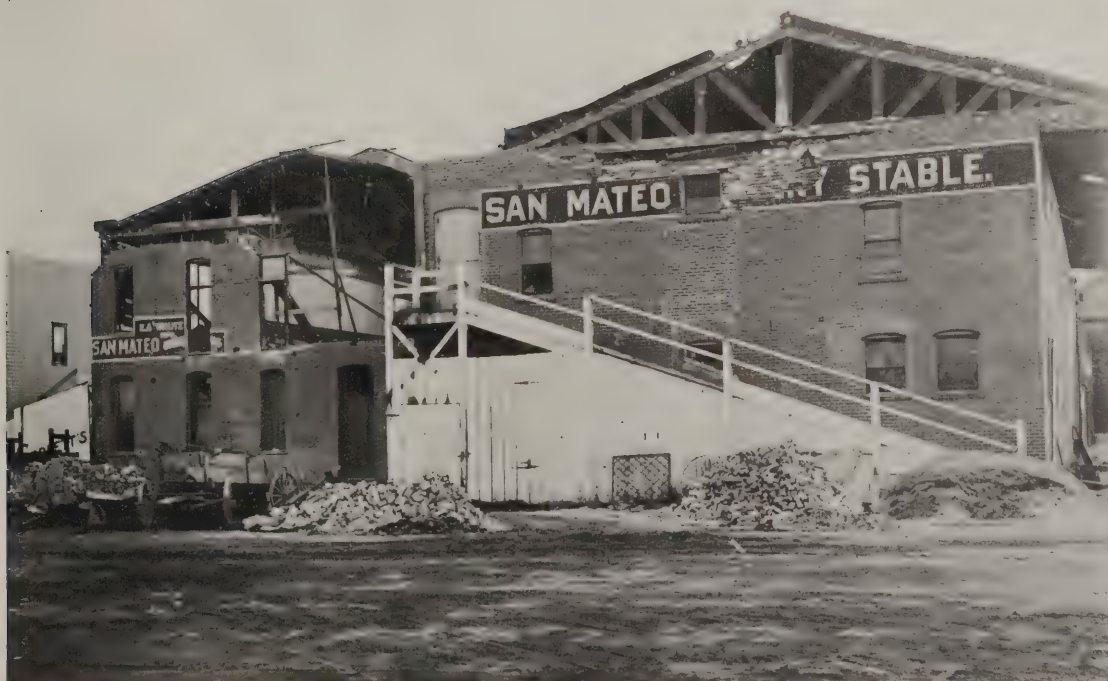
B. Brick stable, San Mateo. Upper story was thrown out and roof dropt one story. Per J. C. B.
